February 27, 2002

**Subject Hydrologic Review of Rainy Creek Restoration Project
Parker Property near Libby, MT**

Water Consulting, Inc

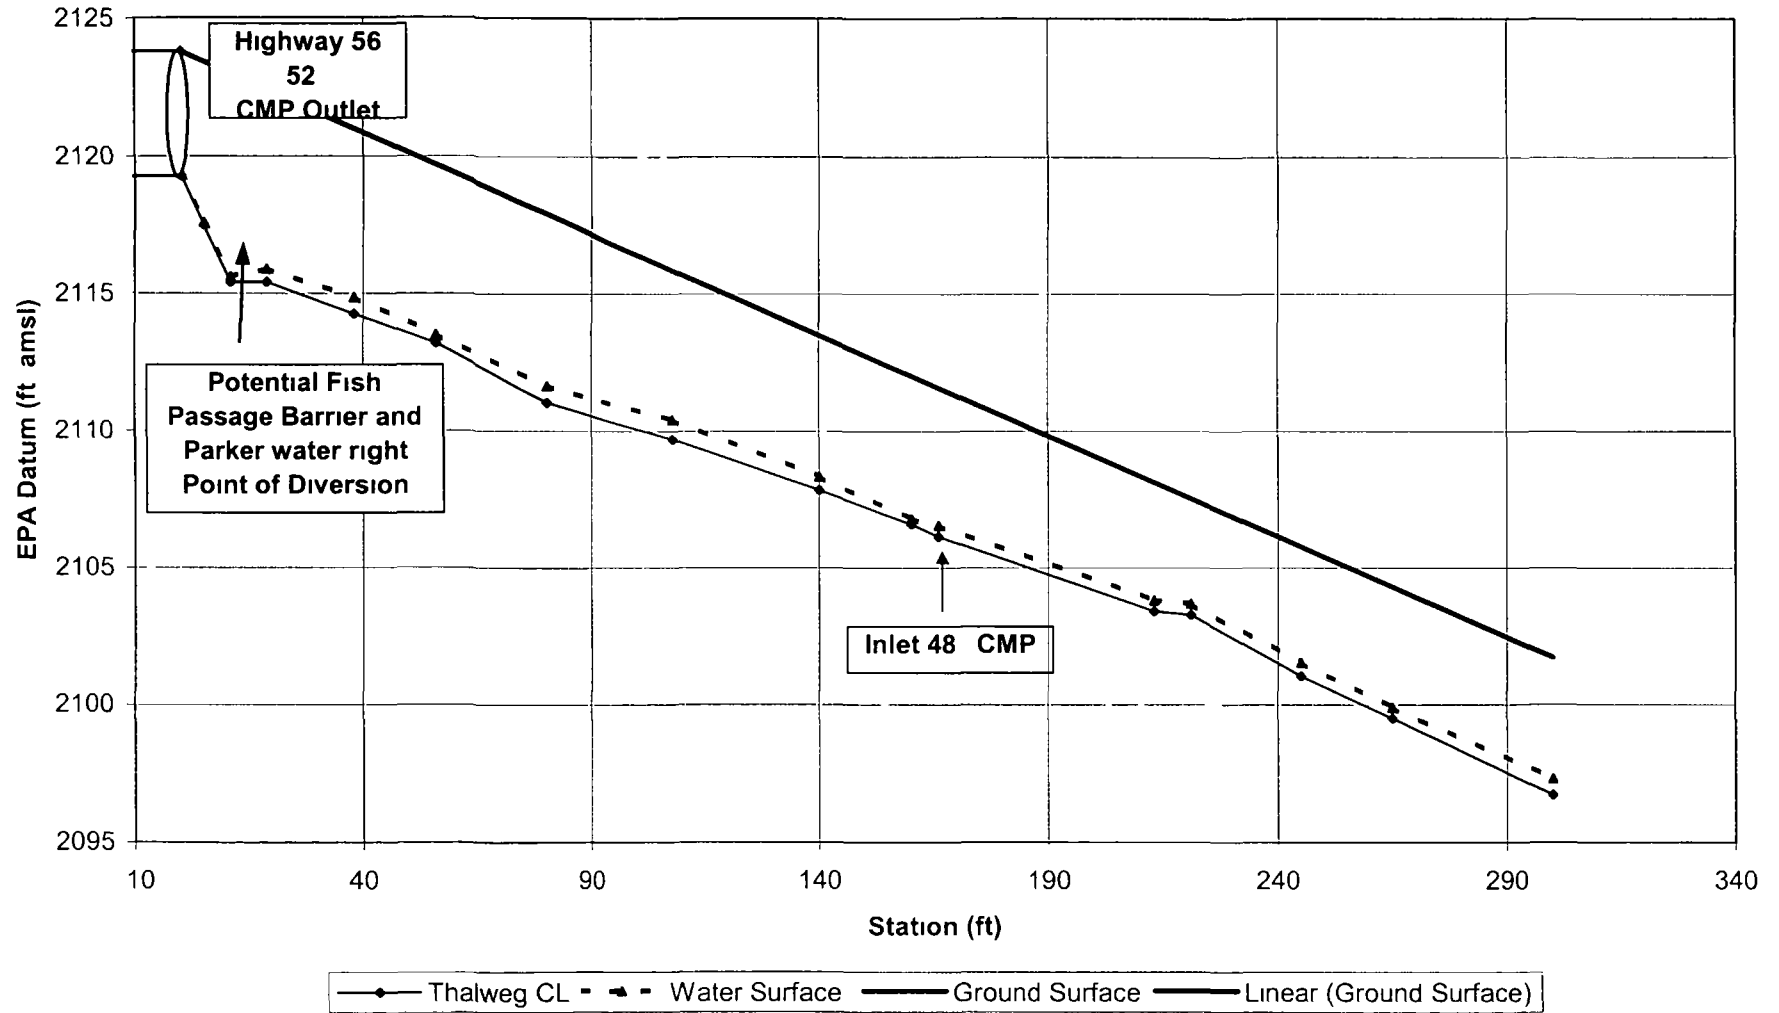
It is evident from the analysis of as-built channel cross-section dimensions and bed profile that the channel, as constructed, is undersized in terms of capacity and lacks the proper bedform features common for these types of streams and geomorphic setting. It is our professional opinion that if maintained in its current configuration, the potential for channel degradation (down cutting) is likely. If this were to occur, the bank placed riprap revetment would be highly susceptible to scour and entrainment. WCI recommends expanding the cross-sectional flow area and installing grade control weirs to maintain bed stability and the sediment transport competency of the project area (see Section 6.0 Conclusion and Recommendations).

Rainy Creek Typical As-Built Longitudinal Profile
Melvin and Lerah Parker Property
(note lack of steps and pools and riffle extension)

- ◆ Install grade control structures (step weirs) to provide for energy dissipation and sediment transport,
- ◆ Modify sections (where needed) of the as-built channel to increase bankfull cross-sectional area,

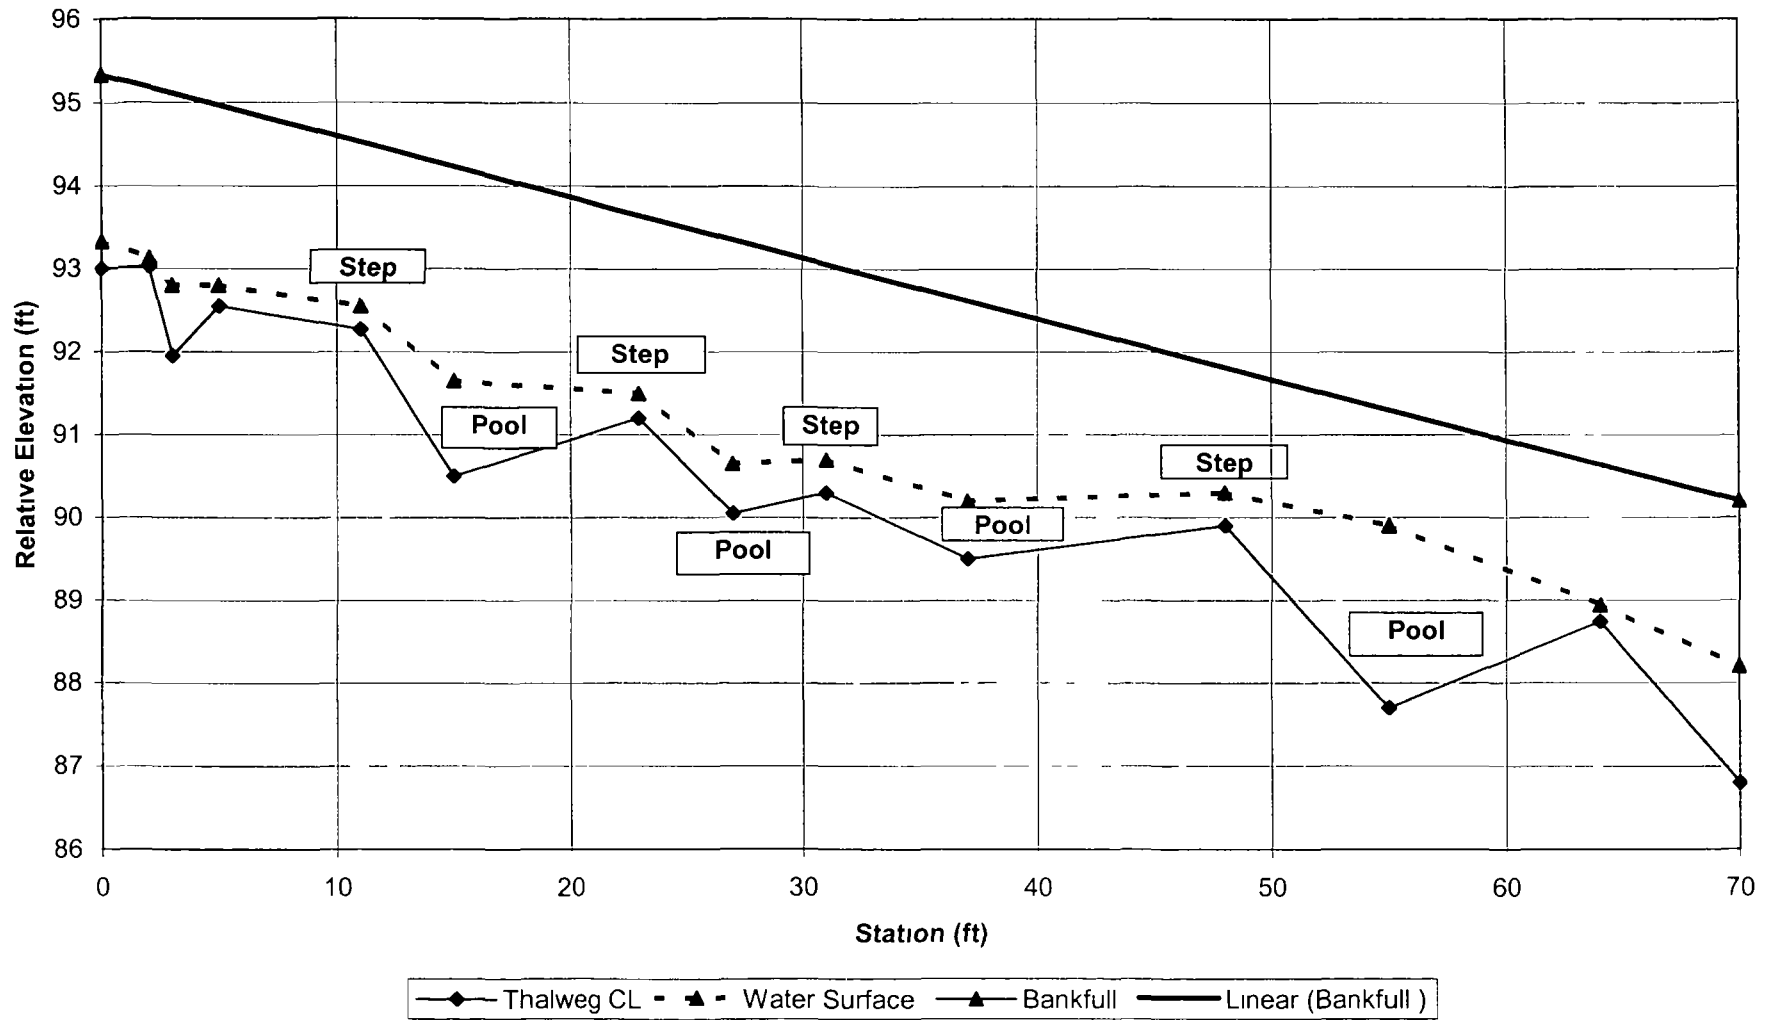
Rainy Creek Reference Longitudinal Profile

Note Undulating Step Pool Bed Profile
(Step Frequency ~1.5 x Bankfull Channel Width)

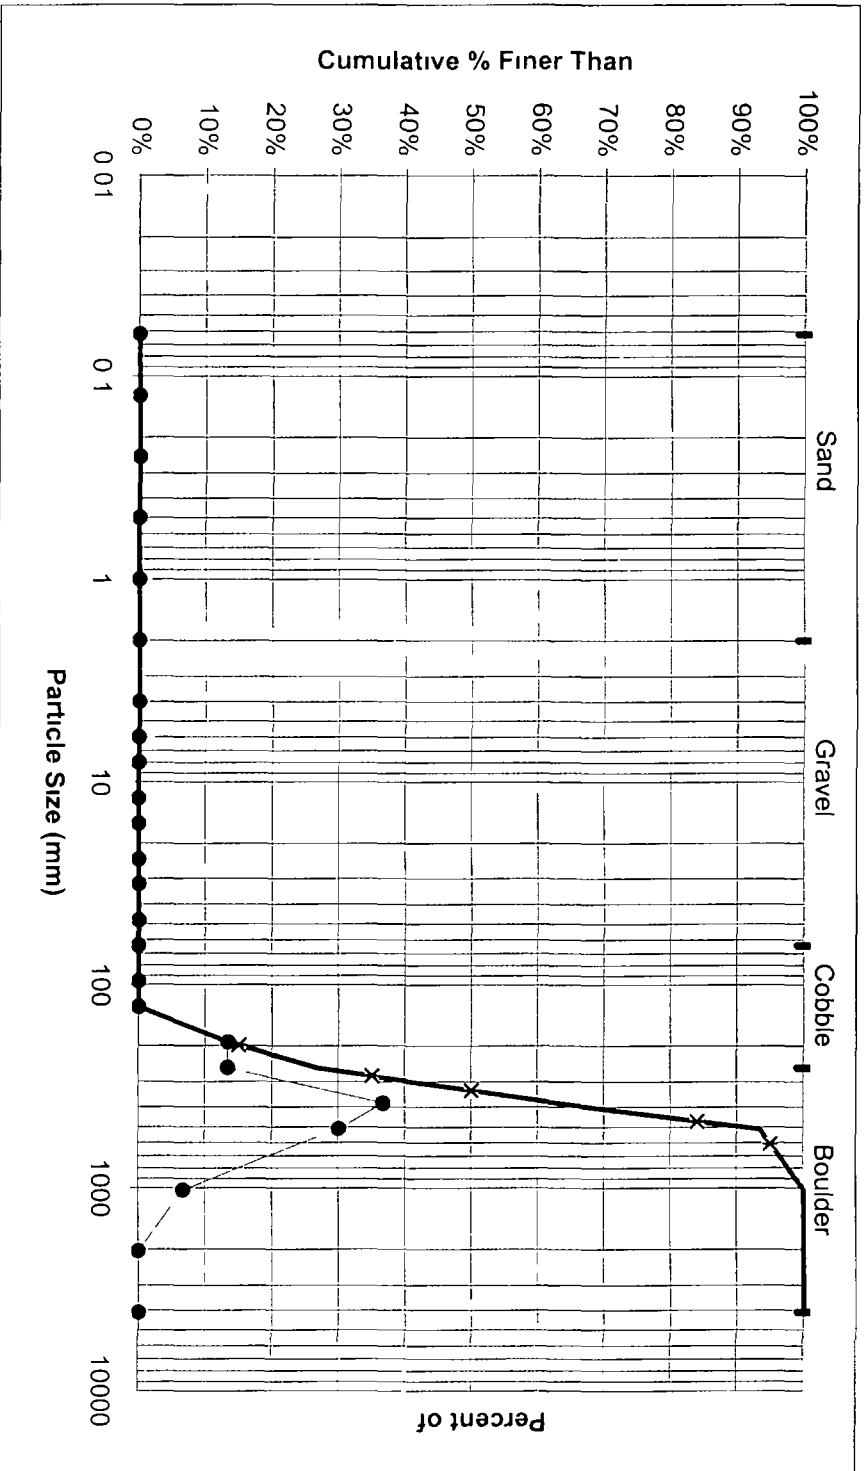
Referring to the MDOT Standard Specifications for Road and Bridge Construction, 1995 edition, the D₅₀ of MDOT Class II riprap is 1 32 ft or 16-inches As evident from Table 3, the median size of riprap placed on both bank is less than the recommended size of 1 32-ft Based on HEC-11 Guidelines for Riprap Sizing, the south bank gradation will be susceptible to scour at flows greater than the 10-year recurrence interval discharge (214 cfs)

COMMENTS Distribution curve noting size of rip rap placed on north bank

- ◆ Excavate several excavation pits to determine the depth of the rip rap toe,
- ◆ Remove smaller size class rip-rap and add larger angular rock sized to MDOT Class II standards on both the north and south banks,

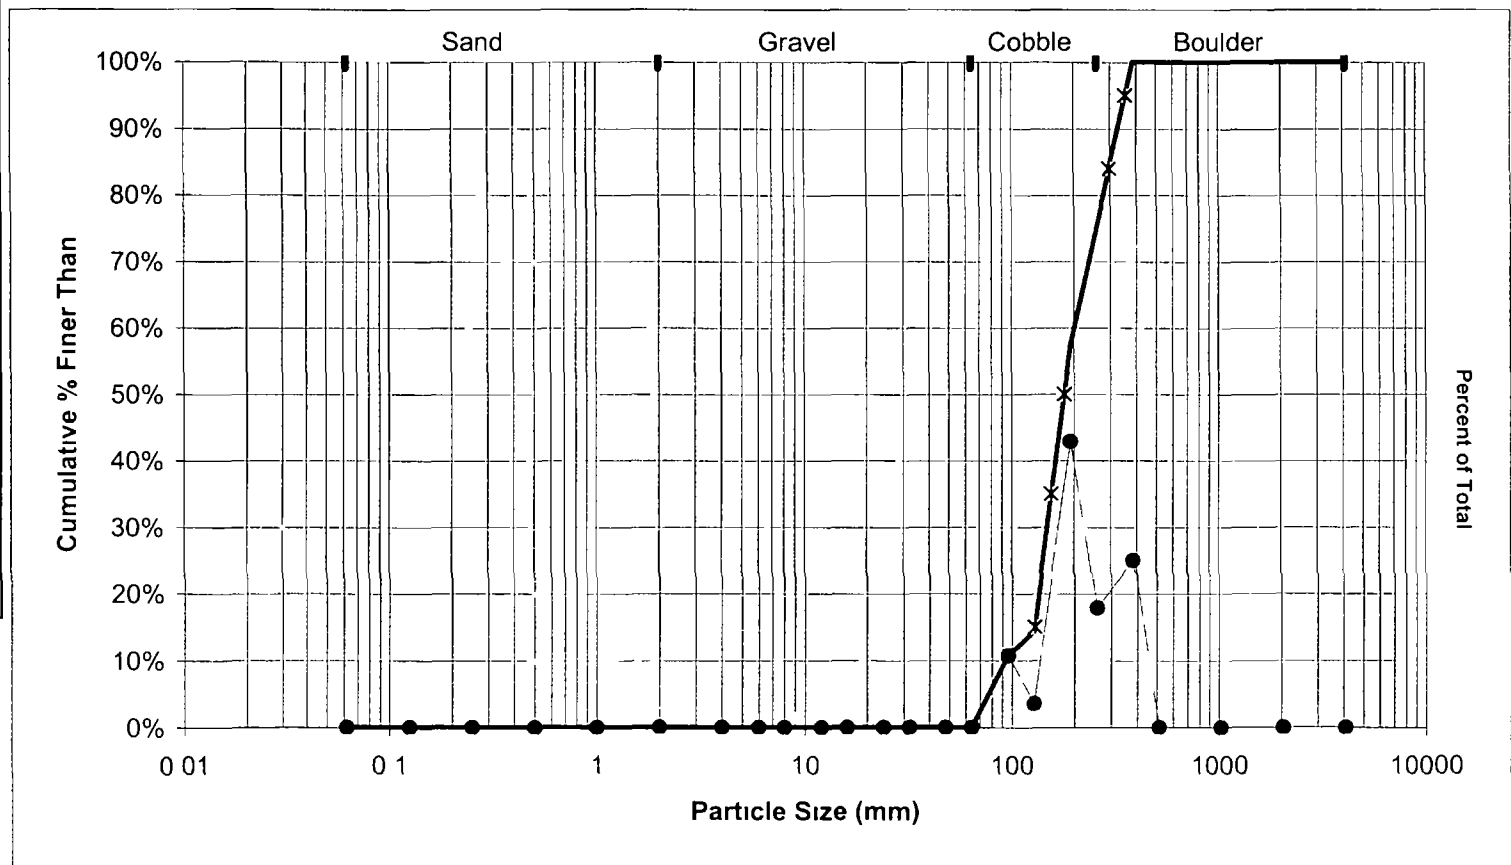
COMMENTS Distribution curve noting size of rip rap placed on south bank

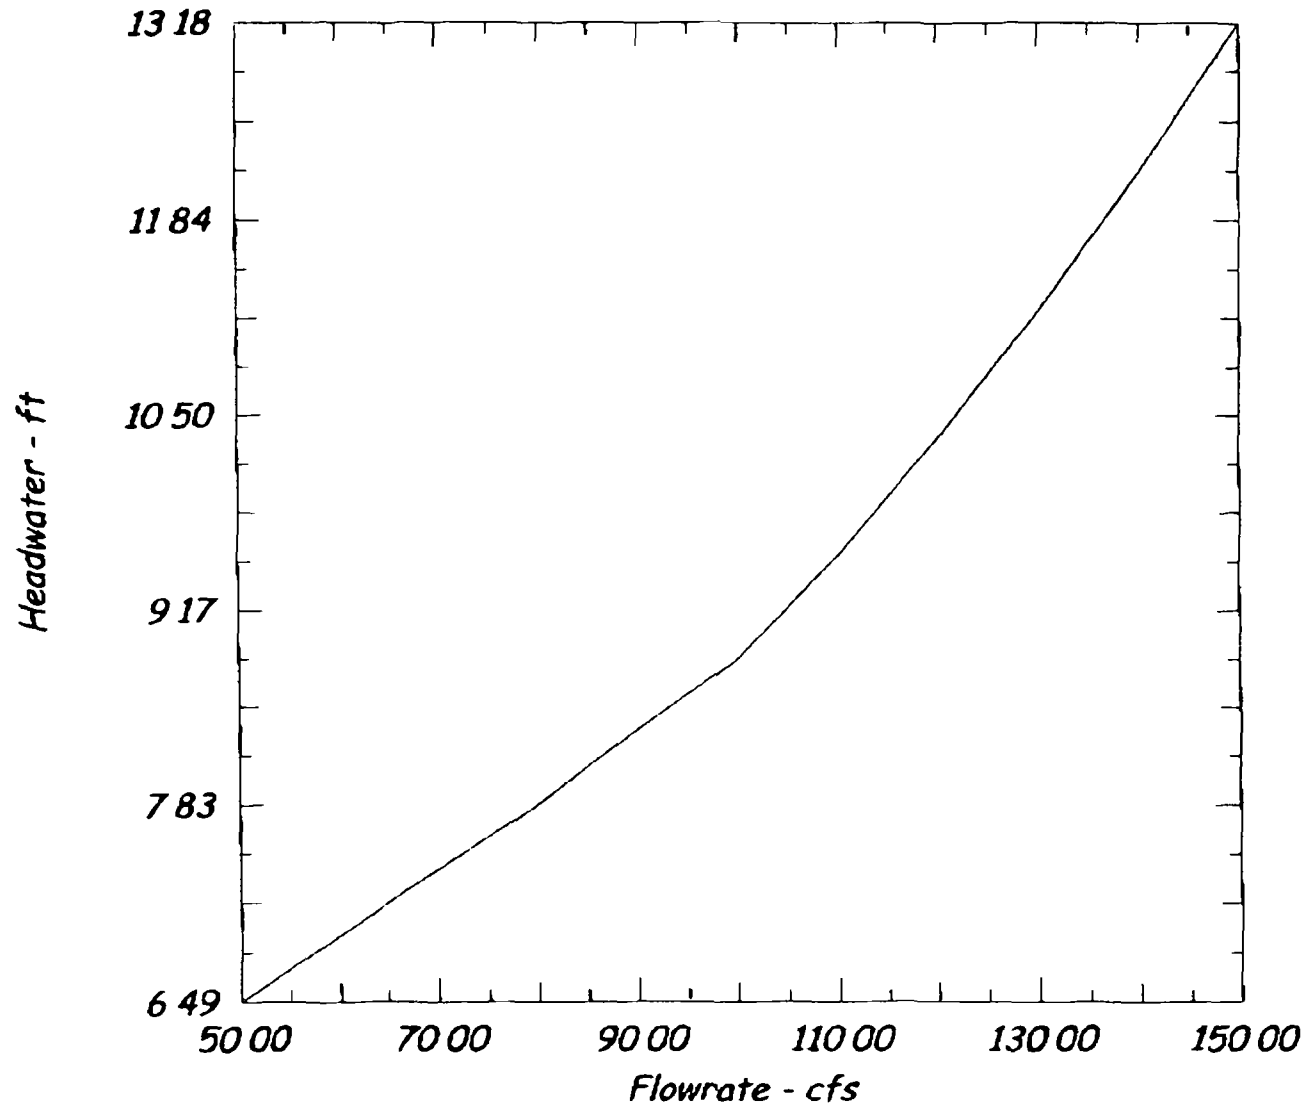
Performance Curve

The maximum capacity of the culvert, with a calculated headwall of 3 0-ft at the inlet, is 120 cfs. Three feet was determined to be the maximum acceptable head at the inlet without jeopardizing the stability of the road fill or overtopping of the road prism. A flow rate of 120 cfs is less than the estimated 10-year recurrence interval discharge. As such, at discharges greater than 120-cfs, flow will cause significant backwater deposition of sediment and likely threaten the structural integrity of the road fill. Backwater deposition would likely initiate a series of in channel adjustments including lateral channel erosion and riprap failure.

Additionally, the outlet velocities likely serve as a velocity barrier to trout migrating from the Kootenai River to the upper reaches of Rainy Creek. While a detailed fish passage analysis was not completed at this time, a more thorough analysis using FishXING is recommended. Table 5 summarizes swimming capabilities of various fish species including brown trout, rainbow trout, and rainbow cutthroat trout x westslope cutthroat hybrids. As evident outlet velocities exceed the swimming speeds of all species included in Table 5.

- ◆ Install velocity baffles in the existing culvert to provide for fish passage and consider installation of floodplain relief culverts to increase the crossing capacity,
